Closing Report – EA04-016

Steering Resistance, Binding, or “Lock-up” caused by a Broken, Bent, Deformed, Fragmented and/or Displaced Turn Signal Canceling Ring (TSCR) Installed in 1998 and 1999 Model Year Volvo Truck North America (VTNA) Heavy Truck Tractors

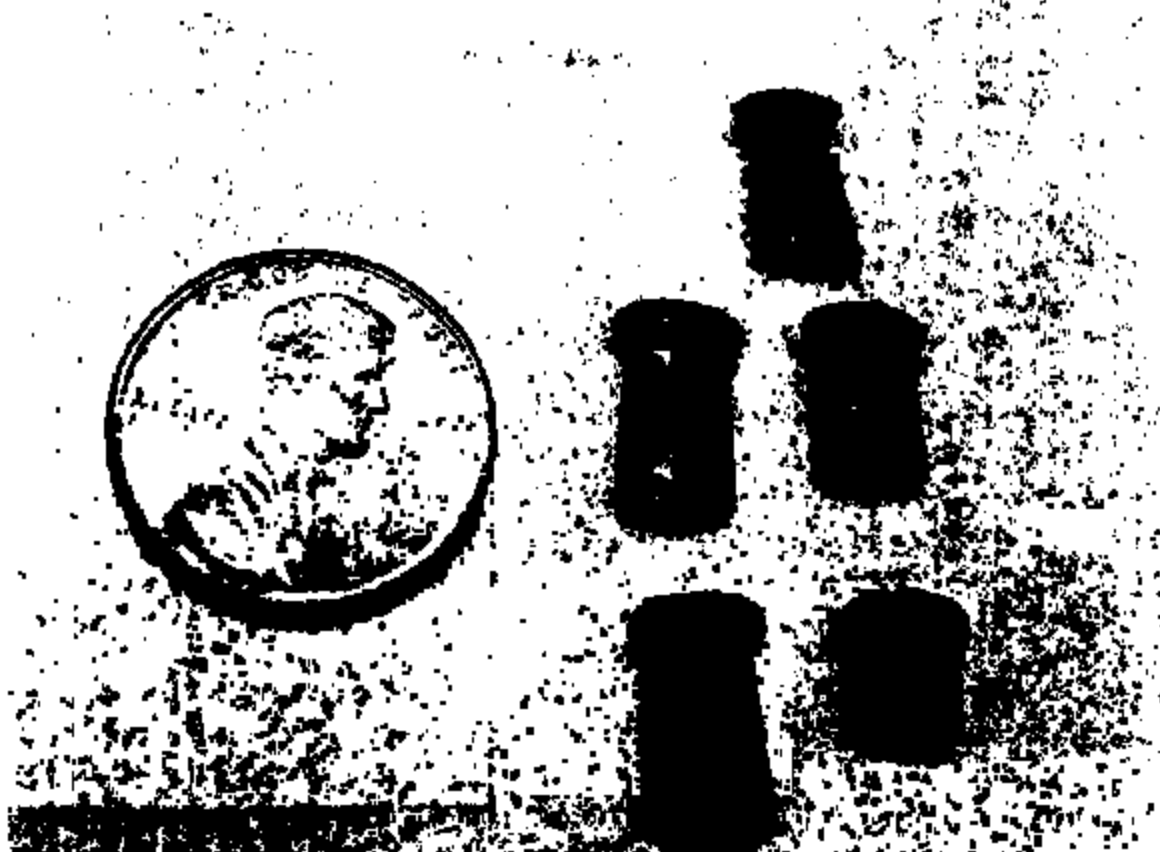
Photograph showing the broken and separated TSCR retention legs removed from FedEx East vehicle unit # 3078. The broken leg pieces exhibit small nicks and abrasions. The penny provides a reference that indicates the size of the broken leg pieces.

In several trials, the small separated piece(s) of the retention legs were promptly ejected from (fell from) the steering wheel assembly. This outcome is consistent with VTNA warranty and field reports that reported finding small pieces of the TSCR that had fallen from the steering assembly.
